MONUMENT RECORD

Corner ID: **CICr_C09**

Quarter Corner

Sections 07 & 18 T07N-R01W, 2nd P.M.

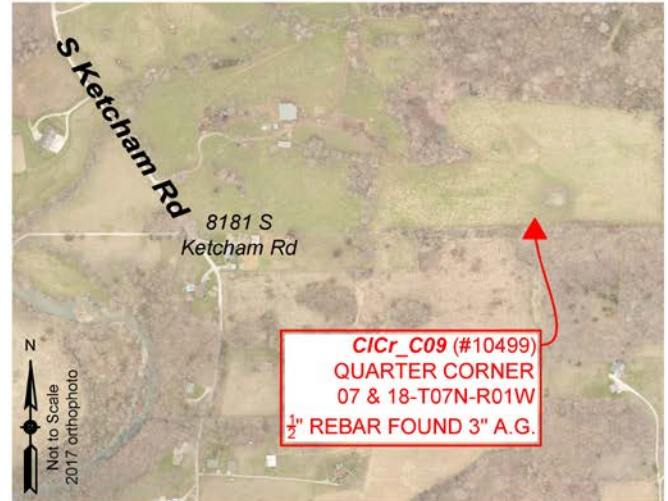
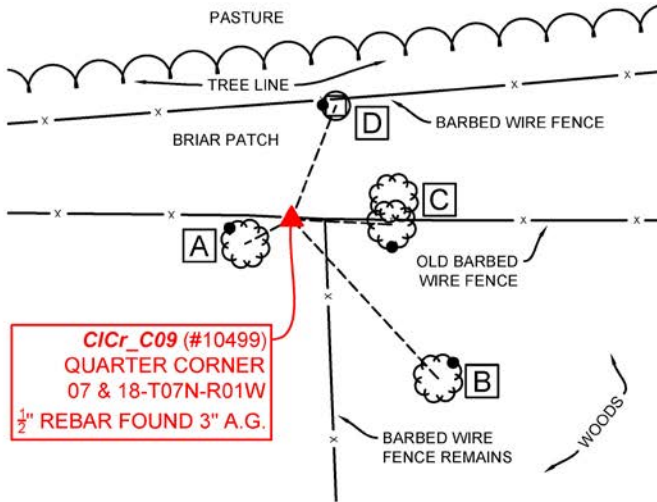
MONUMENT: Describe monument set or found (Include material type, scribing, distance above/below grade, dimensions.)
1/2" rebar found 3" above grade

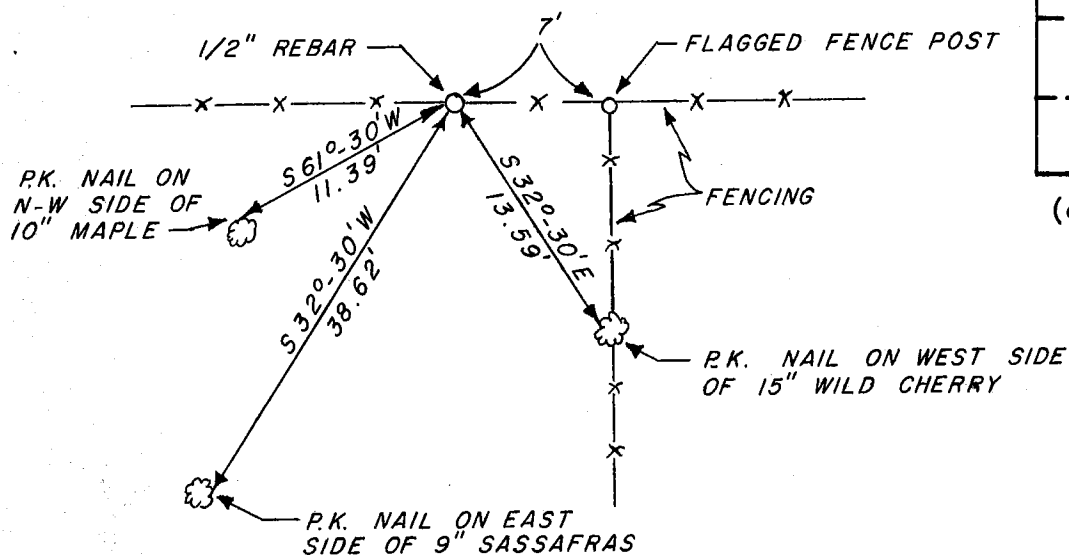
RECOVERY TIE DRAWING

FND. 1/2" REBAR 4" OUT OF GROUND, REBAR IS SOLID IN GROUND &
IN A FENCE ROW.
